Home Inspection Report

5678 Lemon Street
Mount Prospect, IL
60056

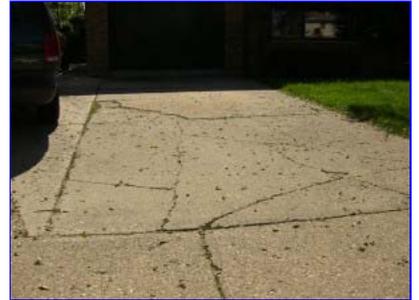
-There are large cracks in the driveway.

There are some large cracks that are consistent with the age of the property, but they do not affect the functionality of the driveway. These cracks should be monitored.

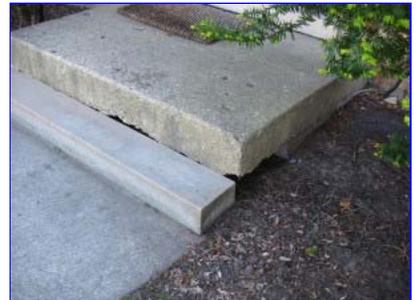
Steps To Building

The stoop has settled near the house creating reverse drainage. We recommend railings on landing & stairs for safety. The area is not properly flashed or caulked. There is evidence of poor drainage. Cracks in concrete or mortar are in need of repair.

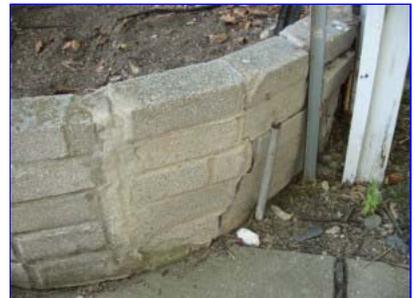
-The retaining wall shows signs of deterioration.

The retaining wall at the back of the home has been damaged. The retaining wall is deteriorating. Cracks in the retaining wall could lead to further cracking and erosion.

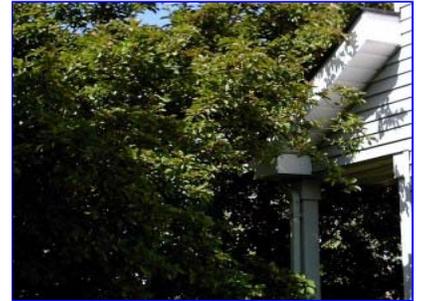
- There are trees growing within 6 feet of the house.
- There are tree branches rubbing against the house.
- There are trees growing too close to power lines.
- There are shrubs growing too close to the foundation.

Keep tree branches trimmed away from the roof. Keep tree branches trimmed away from the siding. Shrubbery is contacting structure. Keep shrubs trimmed away from the siding. We suggest that broken tree limbs be removed.

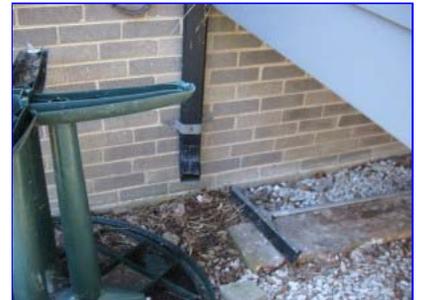
Grading At House Wall

- The ground slopes toward the house creating a flooding hazard.
- There are low-lying areas where water can pool.
- *The grounds were not inspected for roof run-off.

Slope of grade away from structure is inadequate. The grade slopes toward structure. Add fill near the house to slope away approximately 1" per ft. within 6 ft. Keep downspouts extended 5-6 ft. from the house.

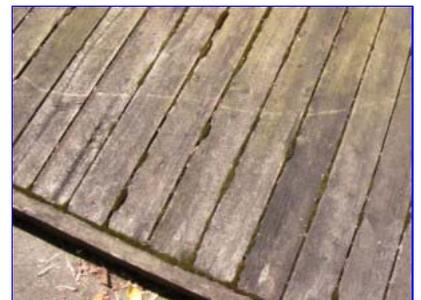
- There is evidence of deterioration where the deck comes in contact with the ground.
- There is evidence of rot on the surfaces of untreated wood.
- There is cracking/deterioration on the deck floor or railings.

- There is separation or sagging due to deterioration.
- There is flashing missing between the deck and the house.

Deck has deteriorated severely due to poor drainage which has caused water damage. Rail system is not securely attached. You should consult a licensed contractor about the needed repairs.

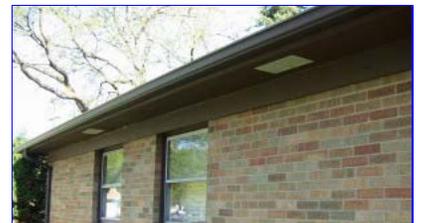
- There are no weep holes in the bottom of brick veneers.

Recommend adding weep holes to the bottom course of bricks to allow possible trapped water to drain out from wall cavity.

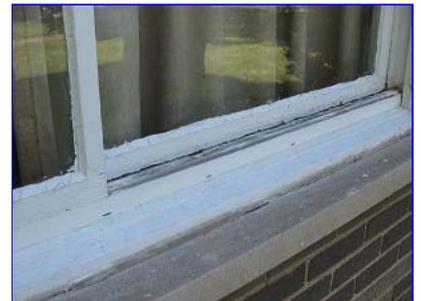
-There are cracked, broken, or missing windows.

This component is in need of minor repair. Windows are not properly caulked. Over time all caulking compounds will deteriorate and require maintenance.

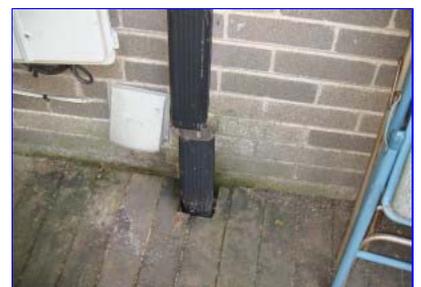
-The downspouts cause water to pool and run toward the house.

-There are spots where downspouts are missing resulting in deterioration to the house.

-There are downspouts missing from the building.

Downspout does not divert water away from foundation properly. There are downspouts that need to be extended. Keep downspouts extended 5' - 6' from the building. Gutters and downspouts need to be added.

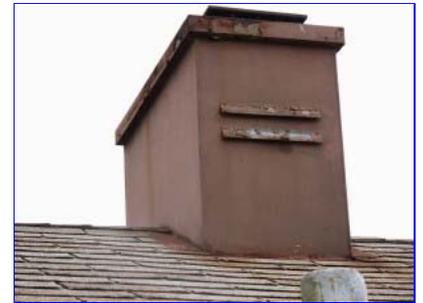
Rusting was observed on chimney cap. Chimney flashing is improperly installed. You should consult a licensed contractor about the needed repairs.

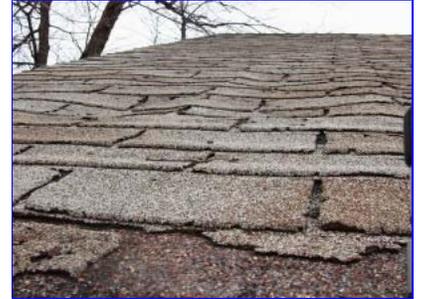
- The roof has weather-worn flashing.
- There is discoloration, rot, mold, or mildew on the roof framing.

There are some sunken areas where it is apparent that the shingles have failed and water is penetrating onto the sheathing. In such cases some of the sheathing may need to be replaced when the shingles are replaced. Further water damage could be occurring within the walls or ceilings as the result of water intrusion.

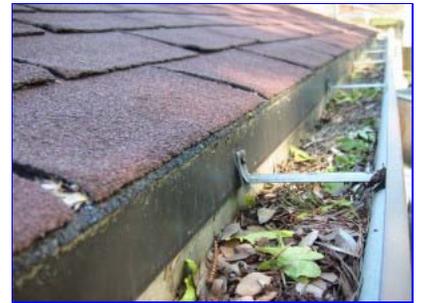
- The gutters are clogged with debris from overhanging trees.
- The gutter/downspout connections are bad.
- There are missing sections of gutters/downspouts.

There are down spouts that need to be extended. Downspout does not divert water away from foundation properly. Damage or failure was observed.

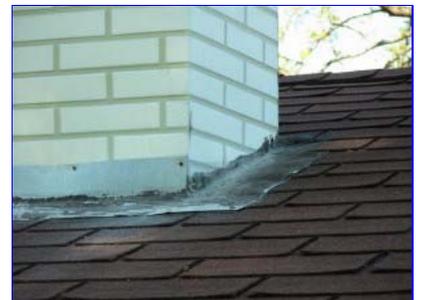
Leaking observed at the chimney flue. Amateur patch job done with roof cement. Flashing at faux chimney cover is flush over shingles and needs replaced.

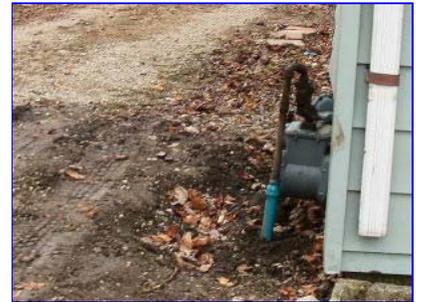
Comments:
This gas meter is located between the driveway and a path where vehicles can be driven or parked which presents a safety hazard. Recommend protecting this location against any impacts.

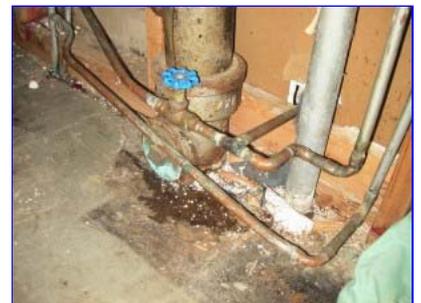
Comments:
Cast iron part of system appears to have a small amount of seepage at the joint as shown in the photo. Old cast iron pipes rust from the inside out and will eventually need to be replaced.

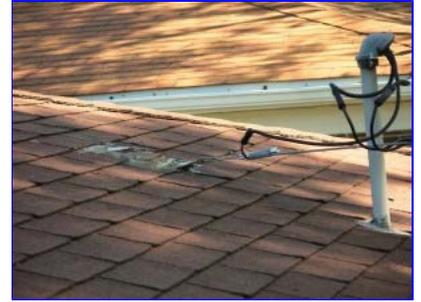
Service Entrance Cable

-The service entrance cable is improperly anchored to the wall.

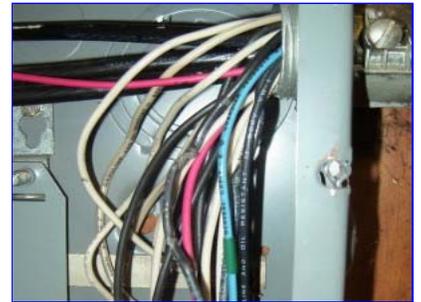
Main Panel

-There is evidence of circuit breakers failing / overloading.

One of the wires shown in the photo has melted insulation which could indicate an over-fused circuit. This could represent a fire hazard and should be examined by an licensed electrician.

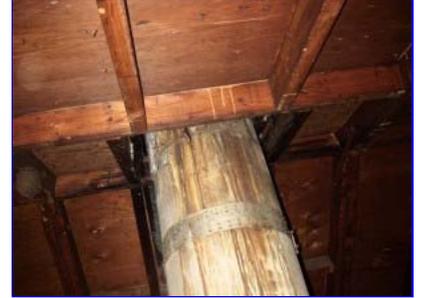
-There are vents that leak or function improperly.

As the photo shows, there are some leaks at flashing points where an exhaust flue goes through the roof. The stains on the flue are indications of this leak.

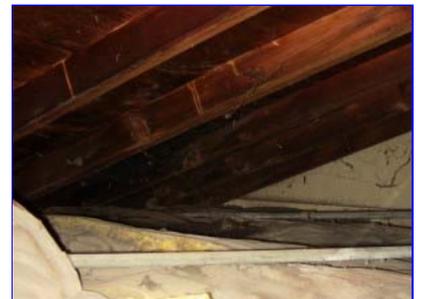
-There are signs of leakages on the sheathing.
-There are signs of water damage to the sheathing.

Dark areas indicative of water penetration on SE area of sheathing below area of suspected shingle failure. There were minimal shiners (nails through the sheathing that missed the roof truss framing.)

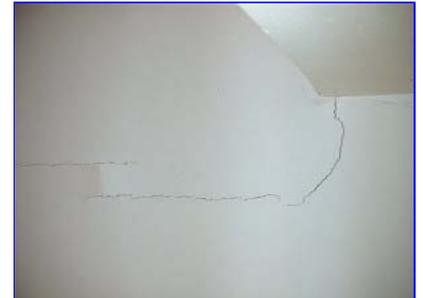
The photo illustrates a crack in the kitchen wall near the ceiling which could indicate uneven settlement in one area of the house.

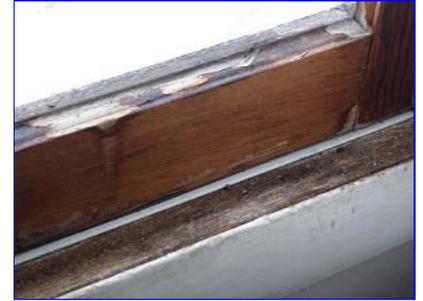
- The windows insulate poorly.
- There are windows stuck or painted shut.
- There are bedrooms without properly functioning egress windows.

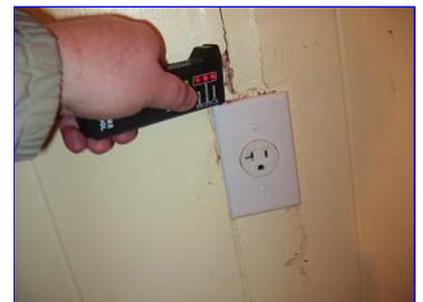
Photo shows the wall next to 240-volt outlet testing high for moisture. It appears that a roof leak is draining down the wall in the laundry room.

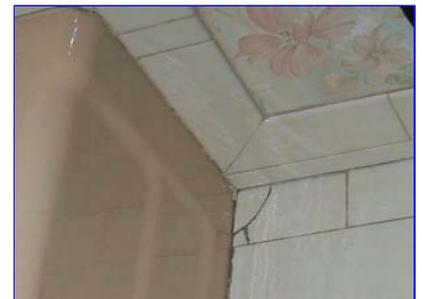
Tile is cracked near tub and needs re-grouted. Flexible caulking needs applied wherever tile meets an edge.

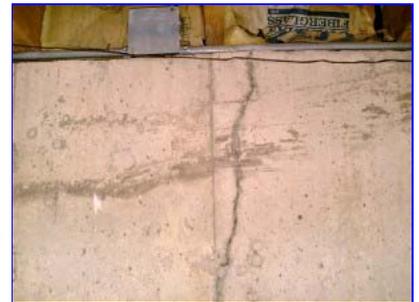
Not all areas of the foundation were visible at the time of the inspection. The foundation appears to be performing from what can be observed. There are several thin cracks visible in the foundation less than a quarter inch wide which are typical of an older masonry foundation.

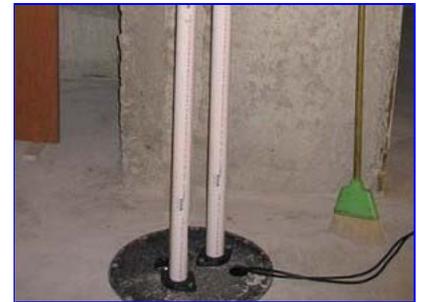
The sewage ejector pump was unplugged and may not function properly. The sewage ejector pump moves waste from basement plumbing fixtures (i.e. toilets, showers, etc) to the level of the sewer line

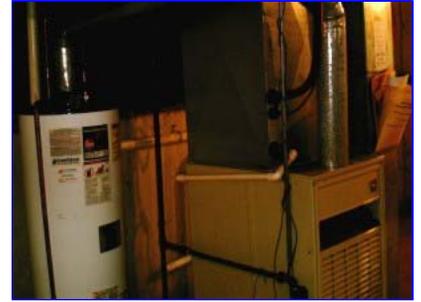
Furnace is over 20 years old and only 70 percent efficient. It is nearing the end of its useful life. Consider budgeting for a high efficiency furnace.

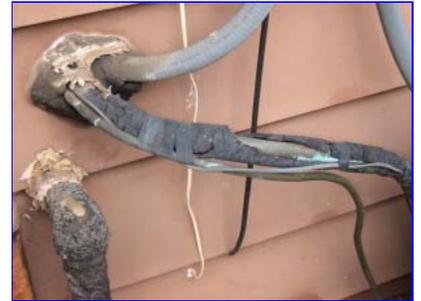
Air Conditioning Unit

- There are obstructions blocking a free air exchange.
- The refrigerant tubes are poorly insulated.
